**CWA COMPLIANCE EVALUATION INSPECTION REPORT
U.S. ENVIRONMENTAL PROTECTION AGENCY
REGION 5**

Purpose: Compliance Evaluation Inspection

Facility: Elite Manufacturing Technologies, Inc
333 Munroe St.
Bloomington IL 60108

Date of Inspection: August 28, 2018

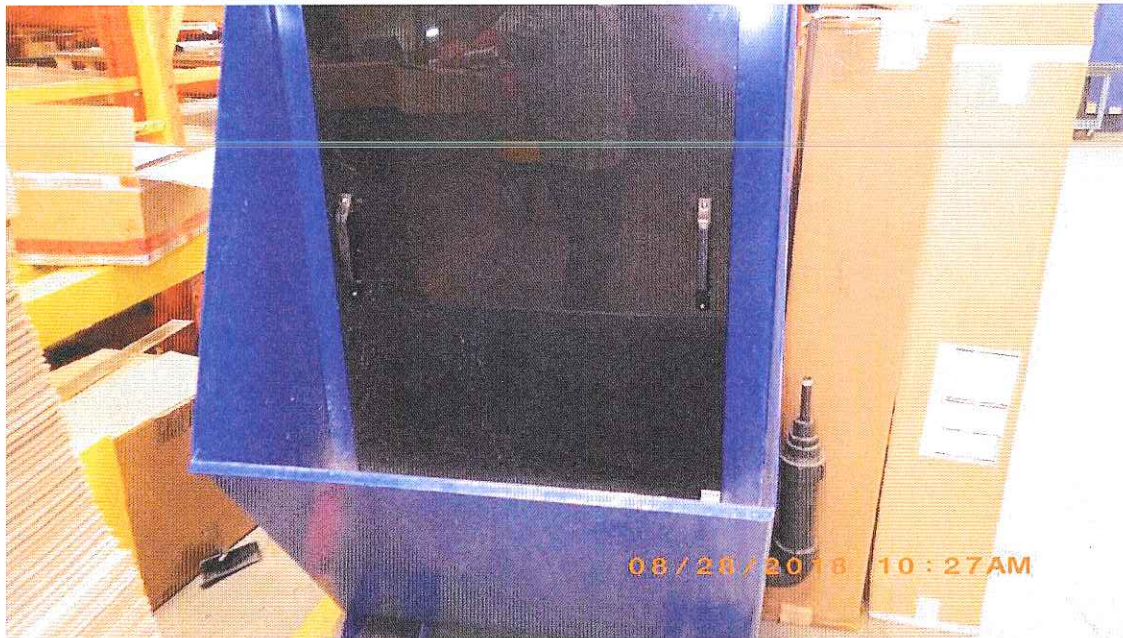
1: RIMG0202

We began the facility tour at 10:20 a.m. in the receiving dock and raw material storage area. Mr. Cresser lead us to the grinding department next, where he pointed us to the stand-alone wet dust collectors on the production floor. The air in the grinding area is filtered through running water in the dust collectors. These wet-dust collectors have a capacity of around 100 gallons, and they are drained to directly to the sewer. Mr. Cresser stated that he did not know how often these wet-dust collectors are drained to the sewer. The grinding department also contains a larger dust-collection system with three booths for workers in closer contact with the parts during the grinding process. Mr. Cresser stated that each booth uses 200 gallons of water to remove dust from the air, and the water from each dust collector is drained to the sewer twice per year. Neither discharge from the free-standing wet-dust collector units nor the dust-collection booths are sampled prior to discharge.

Description: Wet dust collector on plant floor

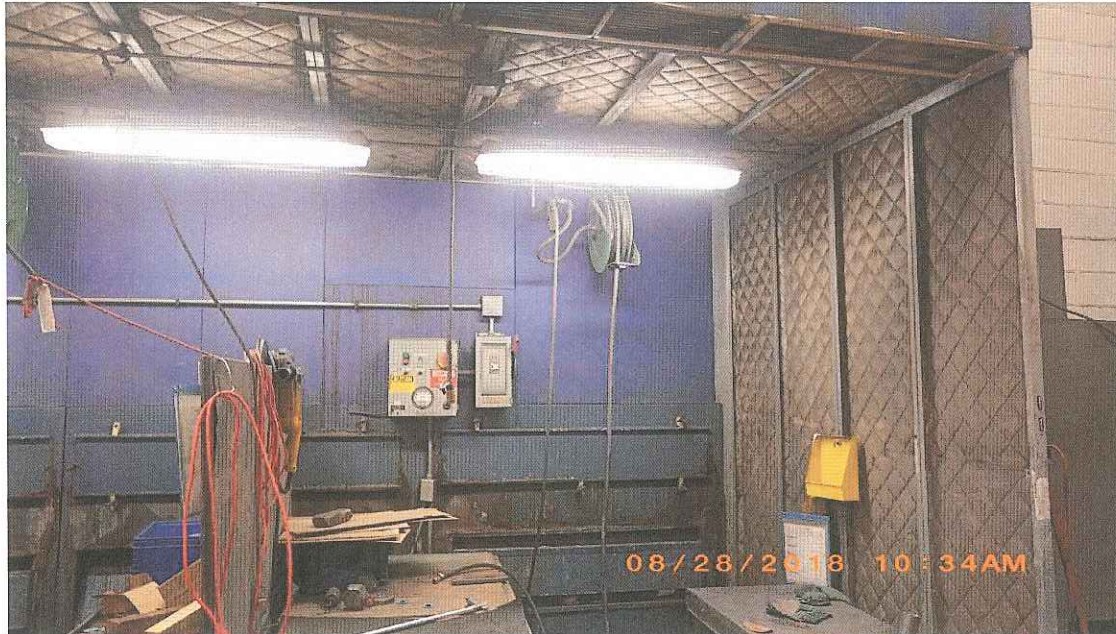
2: RIMG0203

Description: Wet dust collector booth

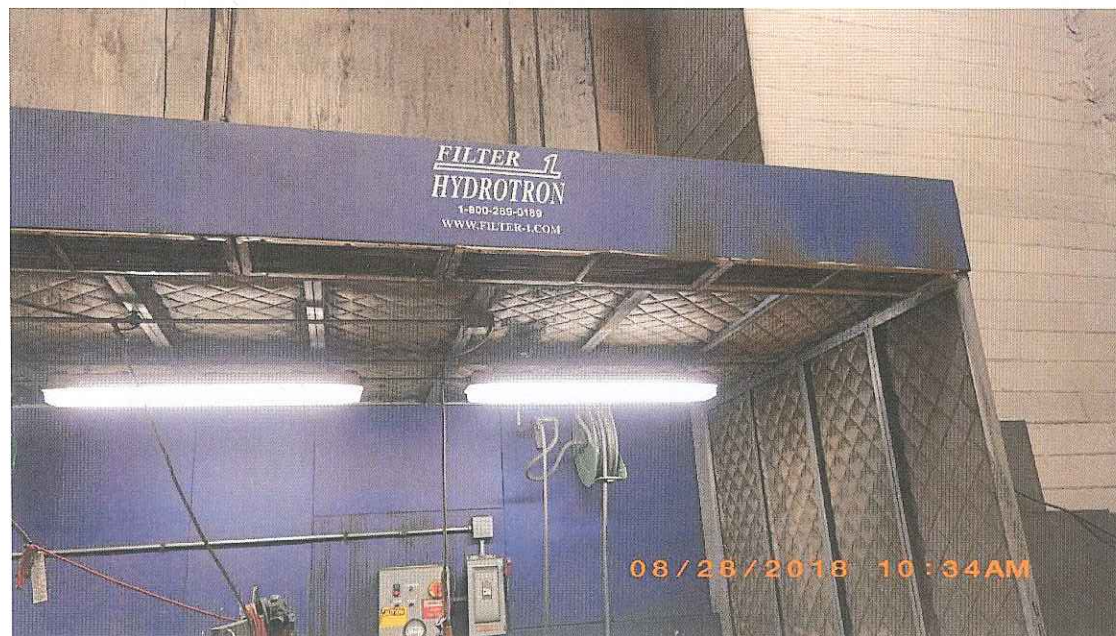
3: RIMG0204

Description: Wet dust collector booth

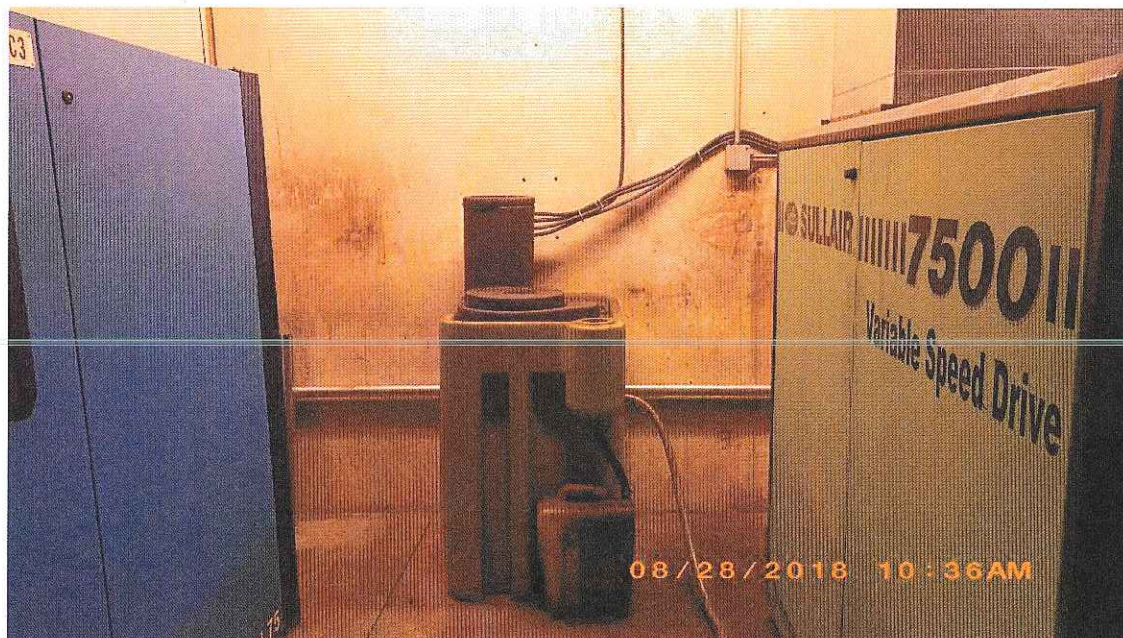
4: RIMG0205

From the grinding department, Mr. Cresser lead us to the air condenser room where water is cooled for the welding processes. The air condenser room has an oil-water separator that removes the trace oil left in the condensate. Mr. Cresser stated that the separated condensate is released to the sewer through the floor. The oil-water separator is serviced once per year, where the filters and oil-absorbing sock is replaced. Elite does not take samples of the condensate discharge.

Description: Oil water separator for air compressor condensate

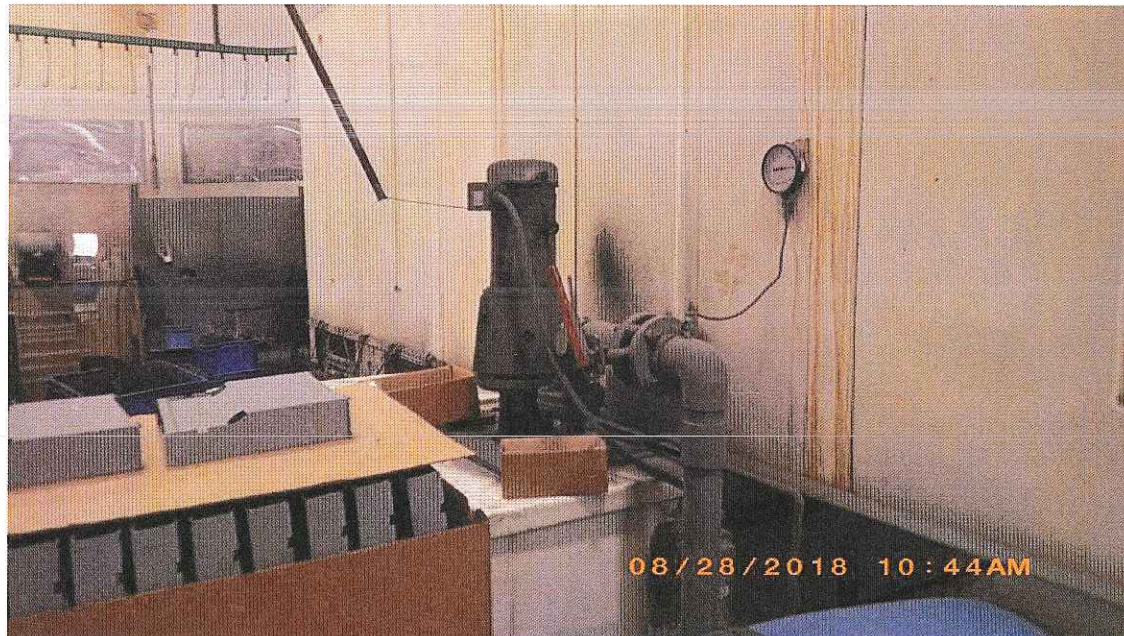
5: RIMG0206

Description: First tank in paint rinse line, containing phosphate

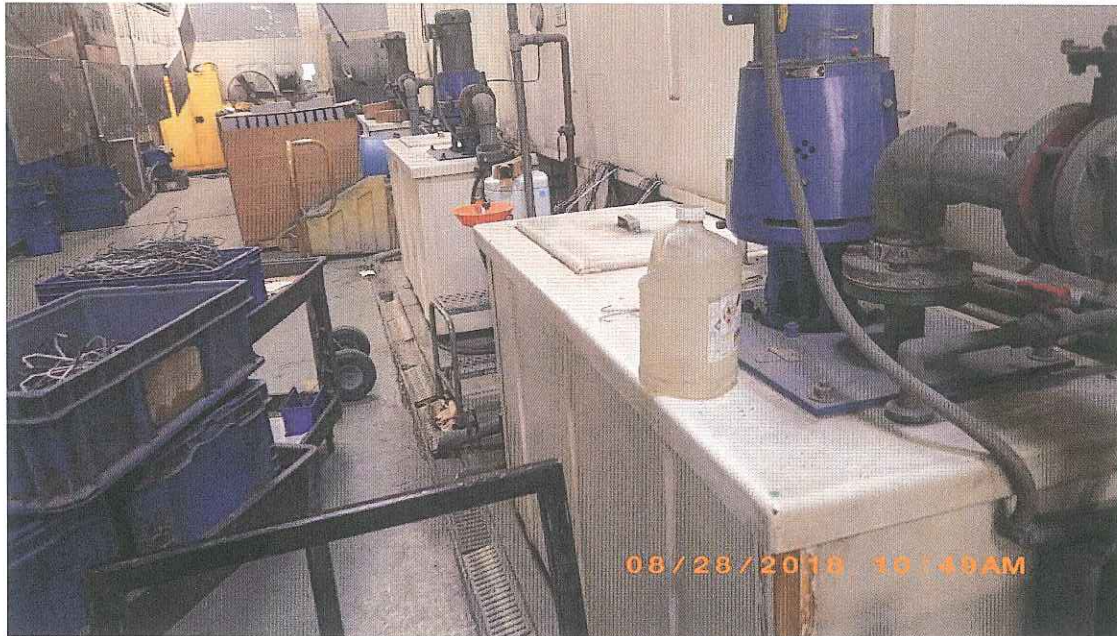
6: RIMG0207

City water is pumped into the third tank, and then overflows into the second tank, which in turn flows into the sewer at a rate of two gallons per minute. Elite also adds an anti-foaming agent to the rinse water (GF ADD 610). This anti-foaming agent is added to the rinse water at a rate of six ounces per day. Both the iron phosphating agent and the additive for the rinse process are stored in drums. The iron phosphating agent drum has sufficient secondary containment, but the rinse additive did not. Mr. Cresser stated that the iron phosphating tank is released to the sewer two or three times per year, and that the rinse tanks are released to the sewer along with the iron phosphating tanks. After conferring with his colleague, Mr. Cresser stated that the pH of the iron

Description: All 3 tanks in the paint rinse line, with tank 3 closest to camera

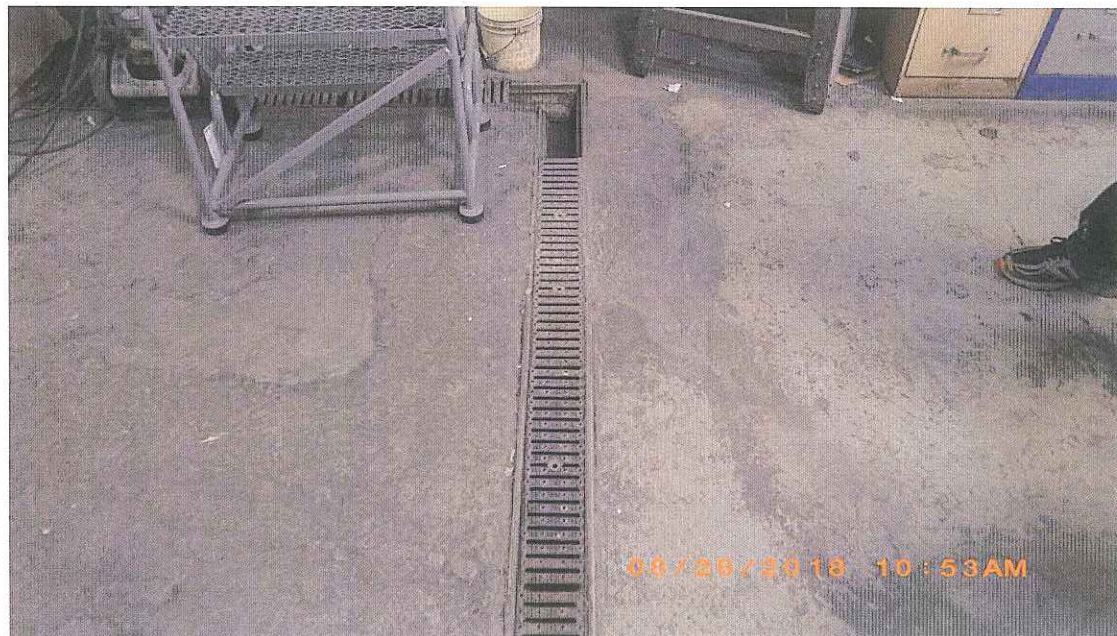
7: RIMG0208

There is a trench drain around the room with the iron phosphating and powder coating process. The trench drain connects directly to the sewer. The trench drain collects potential overflow from the iron phosphating process.

Description: Floor trench in powder painting room

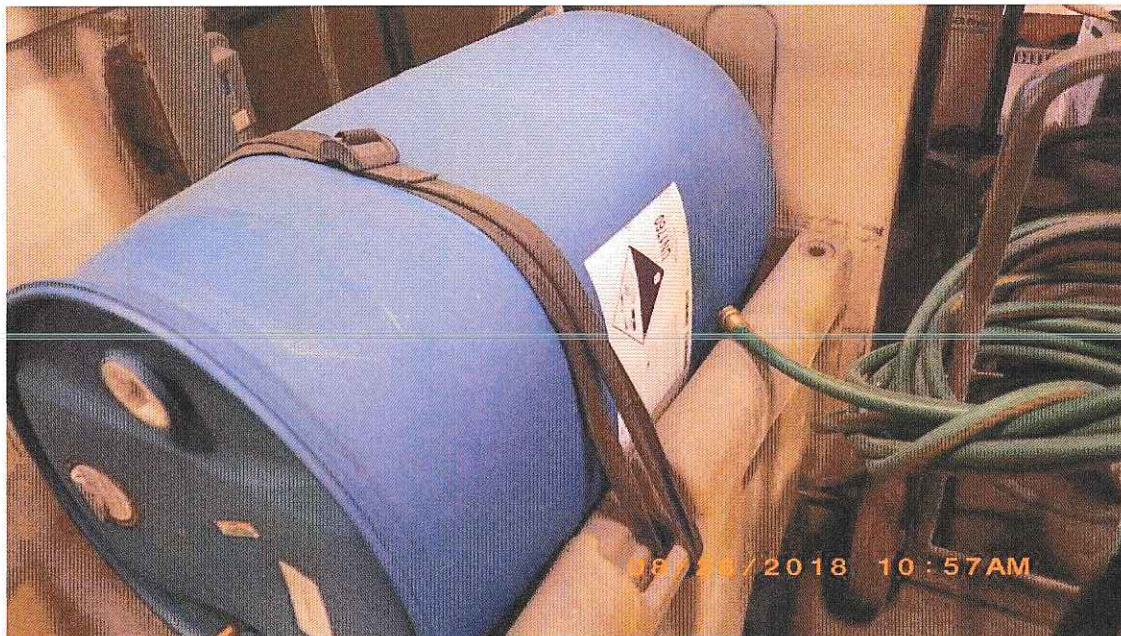
8: RIMG0209

Description: Drum of GF PHOS 427 used in the first tank of the paint rinse line

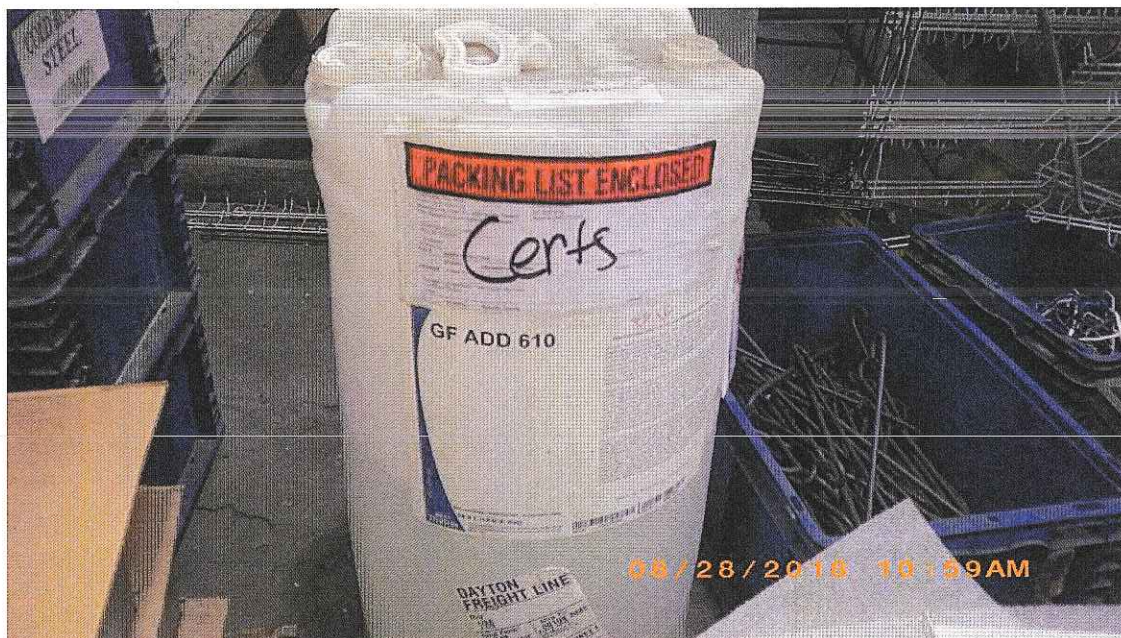
9: RIMG0210

Description: Drum of GF ADD 610 used in the paint rinse line

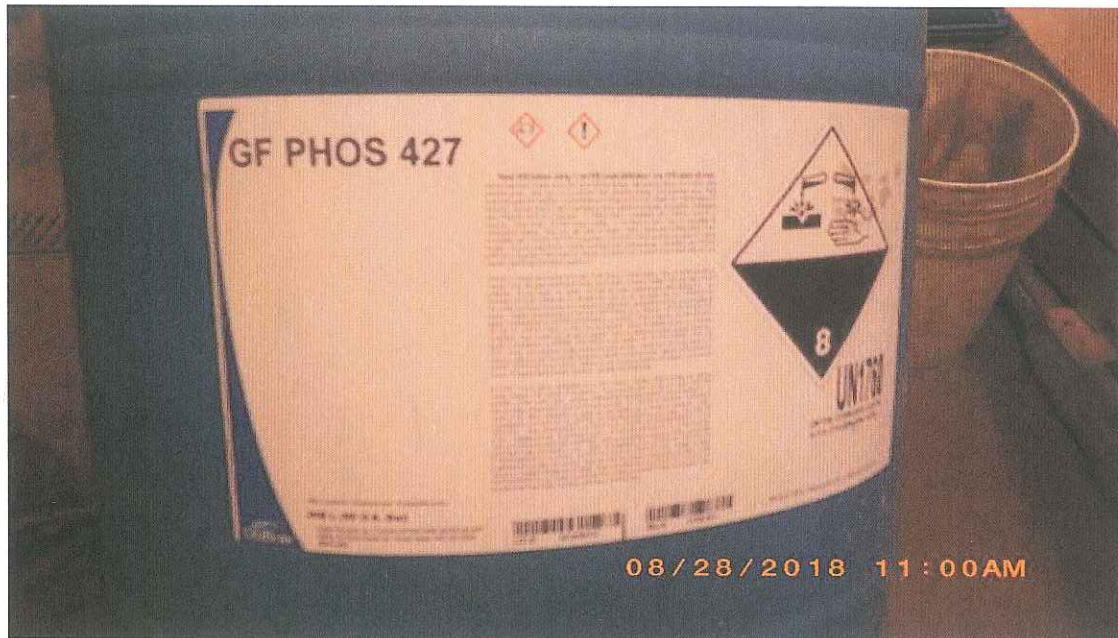
10: RIMG0211

Description: Empty drum of GF PHOS 427
